13 July 2018

Lend Lease  
30 The Bond, 30 Hickson Road  
Millers Point NSW 2000

**RE: PROPOSED EXPANSION OF CESSNOCK CORRECTIONAL CENTRE, NSW  
ASBESTOS IN SOIL MANAGEMENT PLAN**

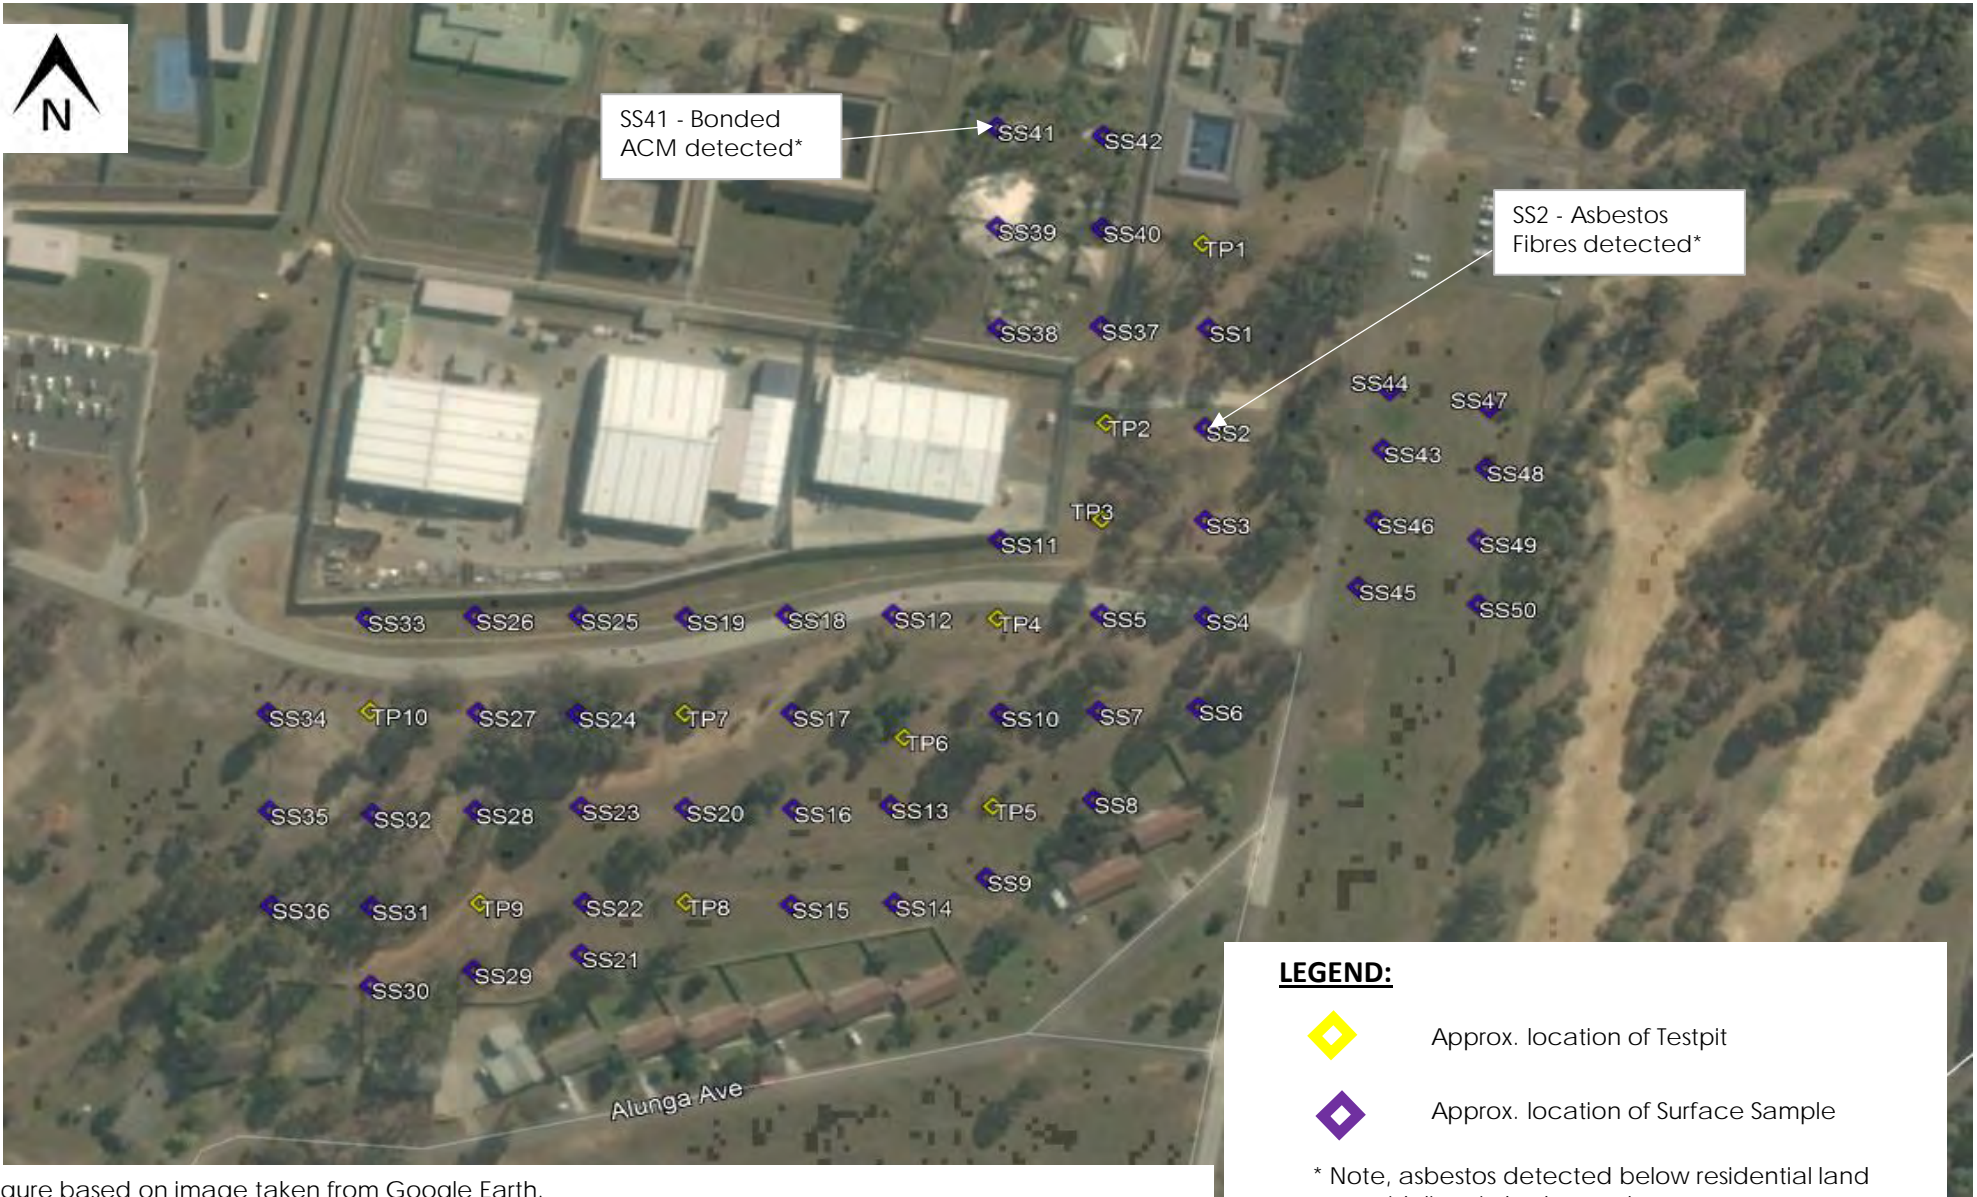
Client:	Lend Lease	Drawing No:	FIGURE 2
Project:	Cessnock Gaol 240 Minimum	Project No:	NEW18P-0117
Location:	Cessnock Gaol, Cessnock	Scale:	N.T.S.
Title:	Sample Locations & Asbestos Detected	Date:	14/06/2018

- A Phase 2 Contamination Assessment was completed on the site by Qualtest in July 2018 (Ref: NEW18P-0117-AA, dated 2 July 2018 (Qualtest, 2018). Asbestos was detected in two samples, below the adopted human health guidelines. The location of the samples containing asbestos is shown in Figure 2:

- Sample SS2 - Chrysotile asbestos was detected in the form of loose fibre bundles (Fibrous Asbestos - FA). The asbestos was detected at 0.00022%, which is below the adopted guideline for residential land use (0.001%); and,

- Sample SS41 - Chrysotile and amosite asbestos was detected in a fragment of ACM (bonded asbestos). The concentration of ACM in the soil sample was calculated to be 0.0041%, which is below the adopted guideline for residential land use (0.01%).

The asbestos impacted material identified at sample location SS2 and SS41 will be excavated and placed under a building slab. Qualtest would recommend the following procedures for the excavation, transport and placement of the asbestos impacted materials:

- An area approximately 5m x 5m (i.e. 2.5m radius) around the sample location (i.e. SS2) would be excavated;
- The depth of impacted material will be assumed to extend to 0.1m and/or the top of the natural residual soils. This depth will be further confirmed by the asbestos clearance visual inspection, and sampling and analysis if fill materials are observed in the base of the excavation;
